CASE STUDY – Snap Fitness 24/7

CLIENT: Catalyst Housing

PROJECT: Snap Fitness 24/7, Wembley, London, England

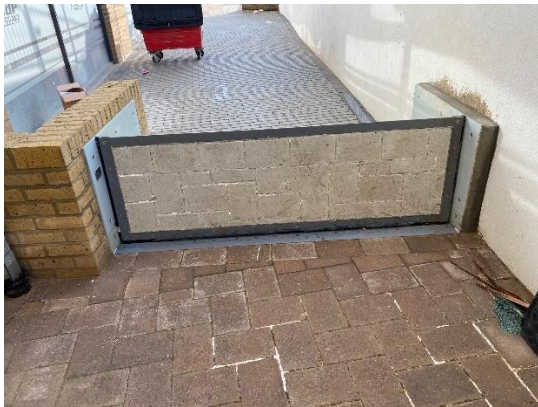
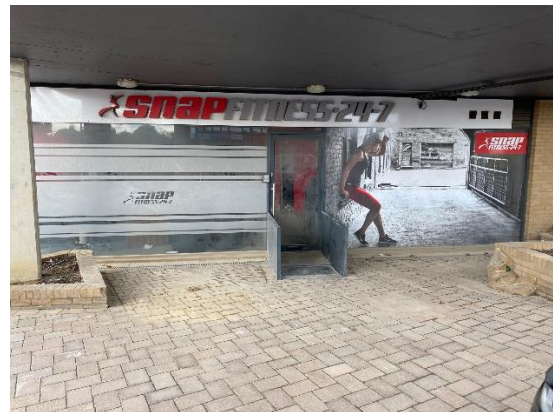
The contour of the ground showing the slope to the front door is clear in the above photo. The barriers at the side of the building and the front door, along with the stormwater attenuation under the permeable paving slabs, highlight both the below and above ground storage areas that were created in this unique flood mitigation strategy.

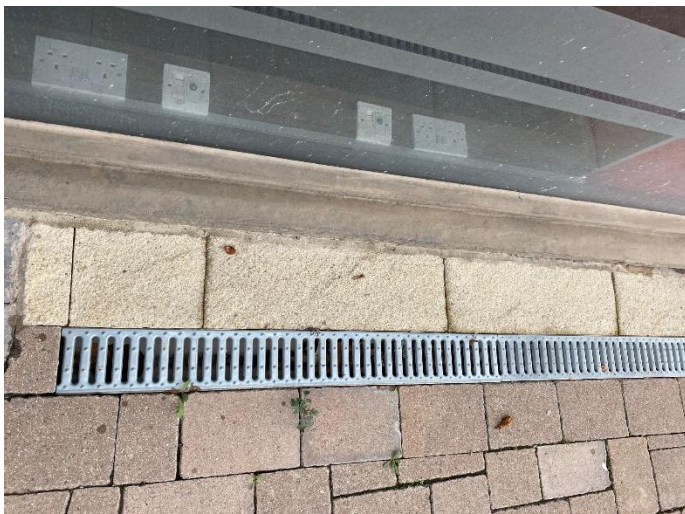
This photo shows the French drain that is used along with the permeable paving to aid infiltration into the below ground tank, whilst also showcasing the tanking (beige) of the foundations and curtain walling seals.

The curtain wall was certified as structurally sound up to the designed flood protection height of 600mm.
