UK Case Studies

- Edenside Barn, Cumbria
- Bower Yard, Ironbridge
- Trout Hotel, Cumbria

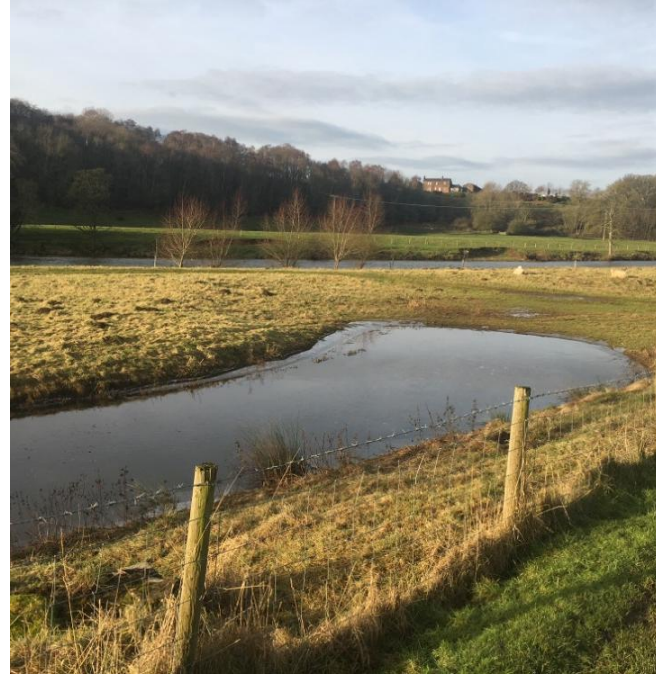
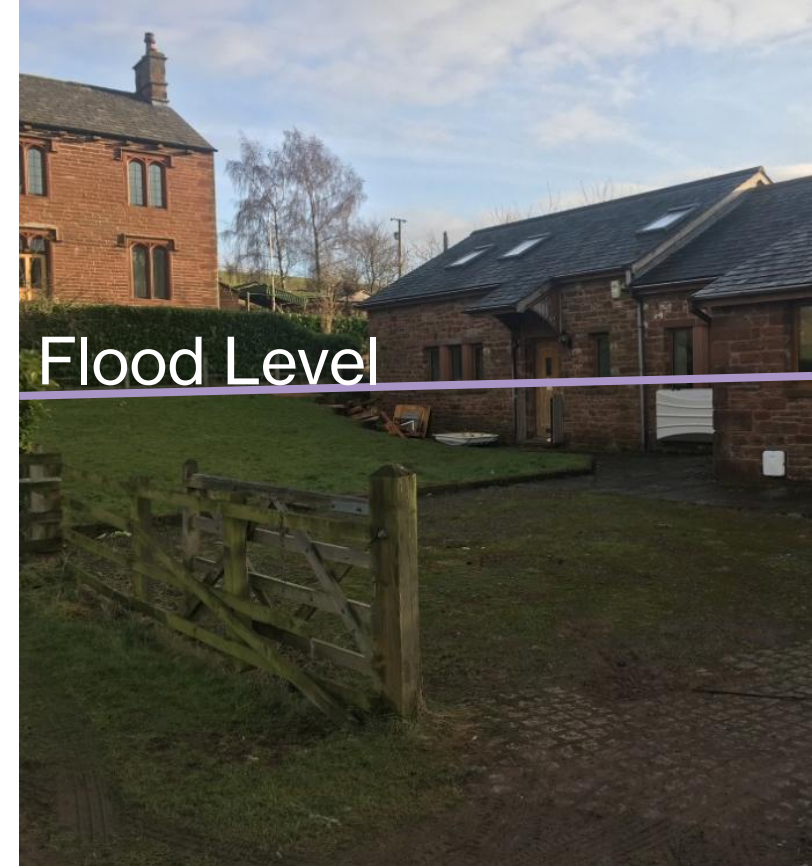
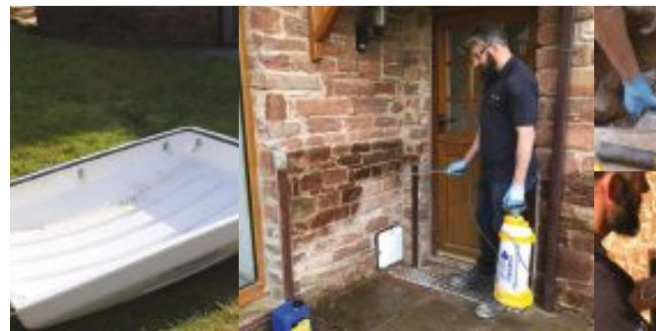
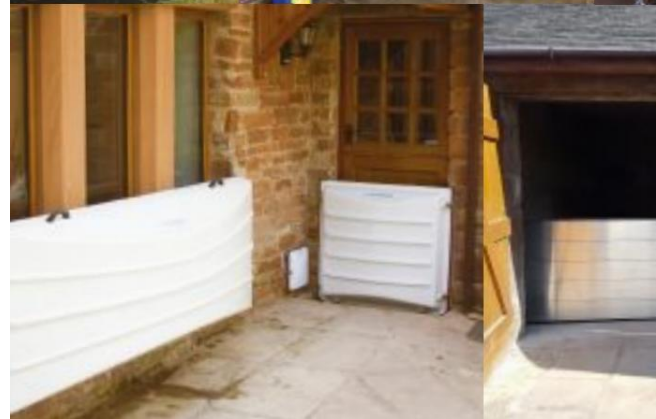
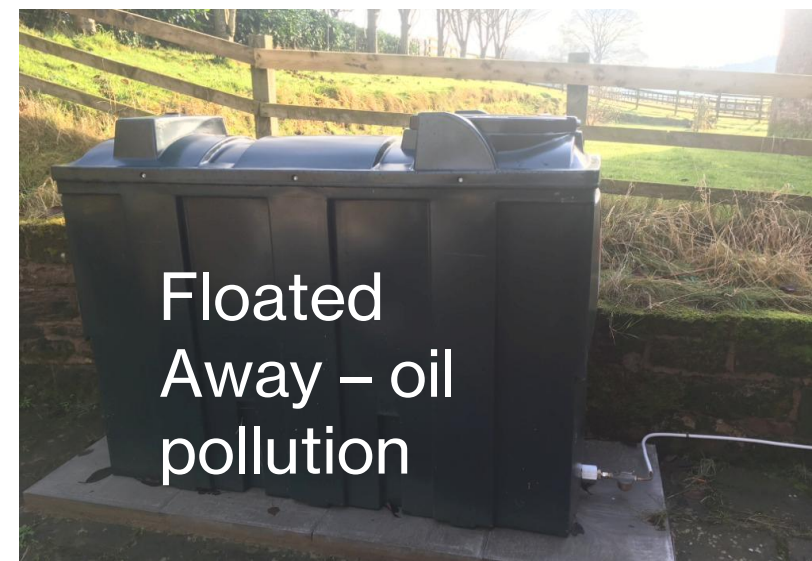
- Next to the River Eden with an elevation of 5m AoD
- Protected with 900mm high flood barriers after previous flood
- 2015 floods overtopped the barriers
 - Storm Desmond
 - Prolonged intense rainfall of up to 341.4 mm
- Homeowner out of home for 2 years

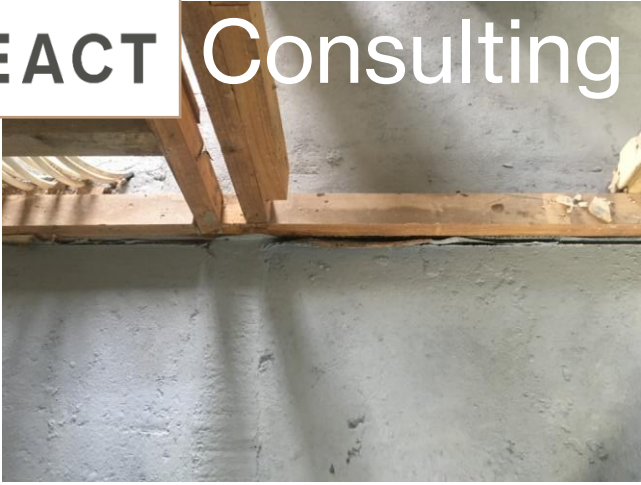
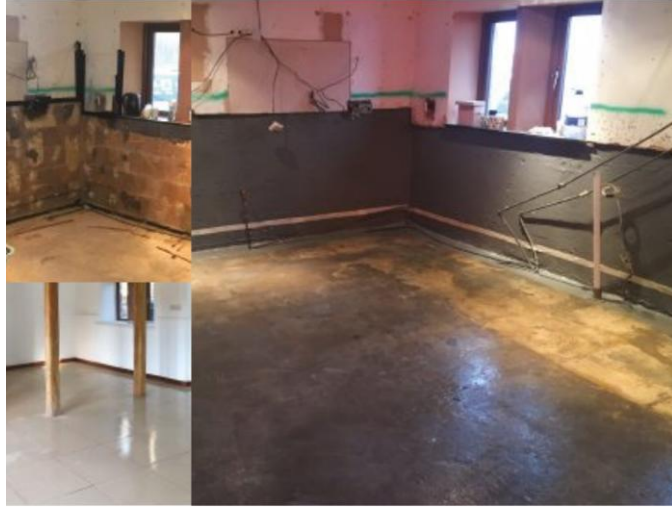
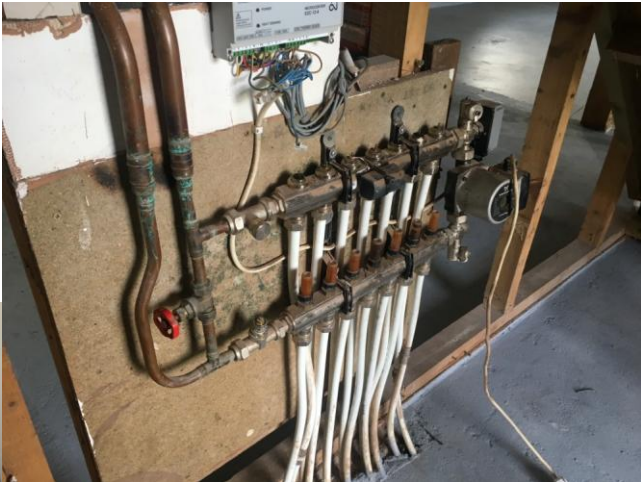
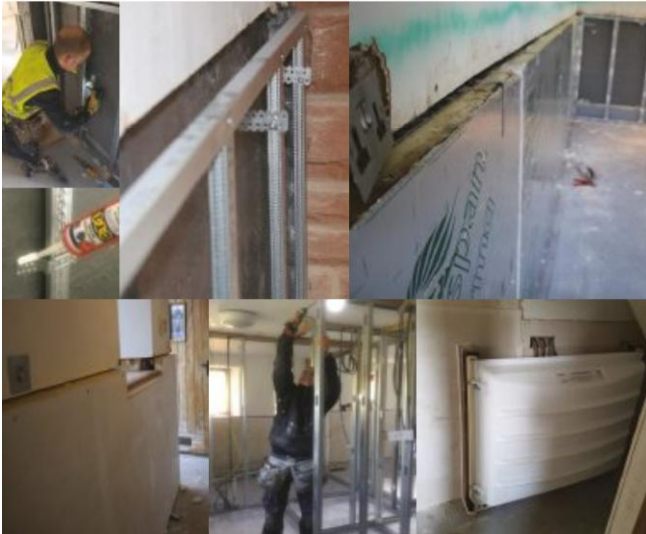
- Wood stud wall replaced with metal frames on perimeter walls
- Closed cell installation panels
 - Introduced Dado rail feature at flood height
- Tiled floor, marine grout & glue
- Dragonboard Vs Gypsum
- Underfloor heating protected

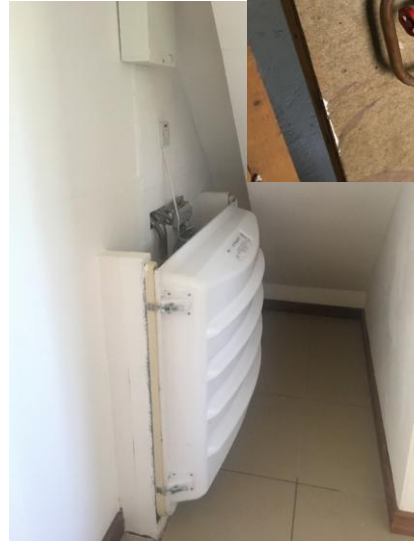
**Design
Detail –
External
wall &
floor**

The detailing on the installation is key

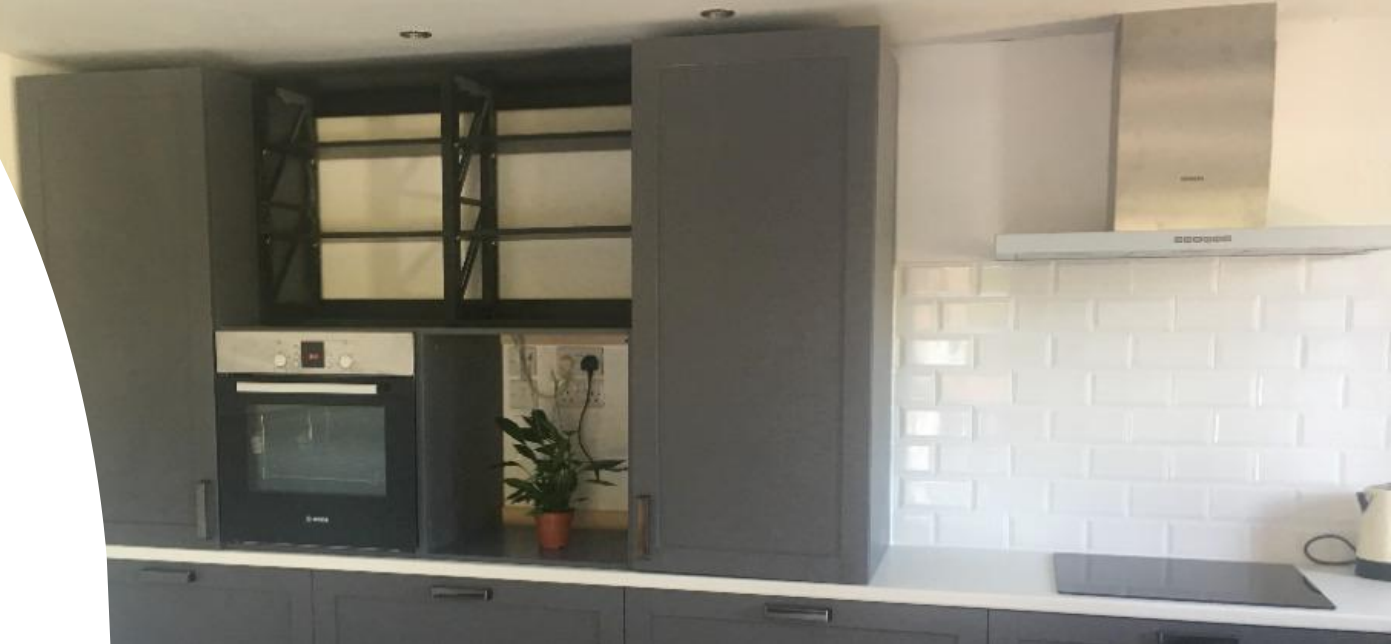
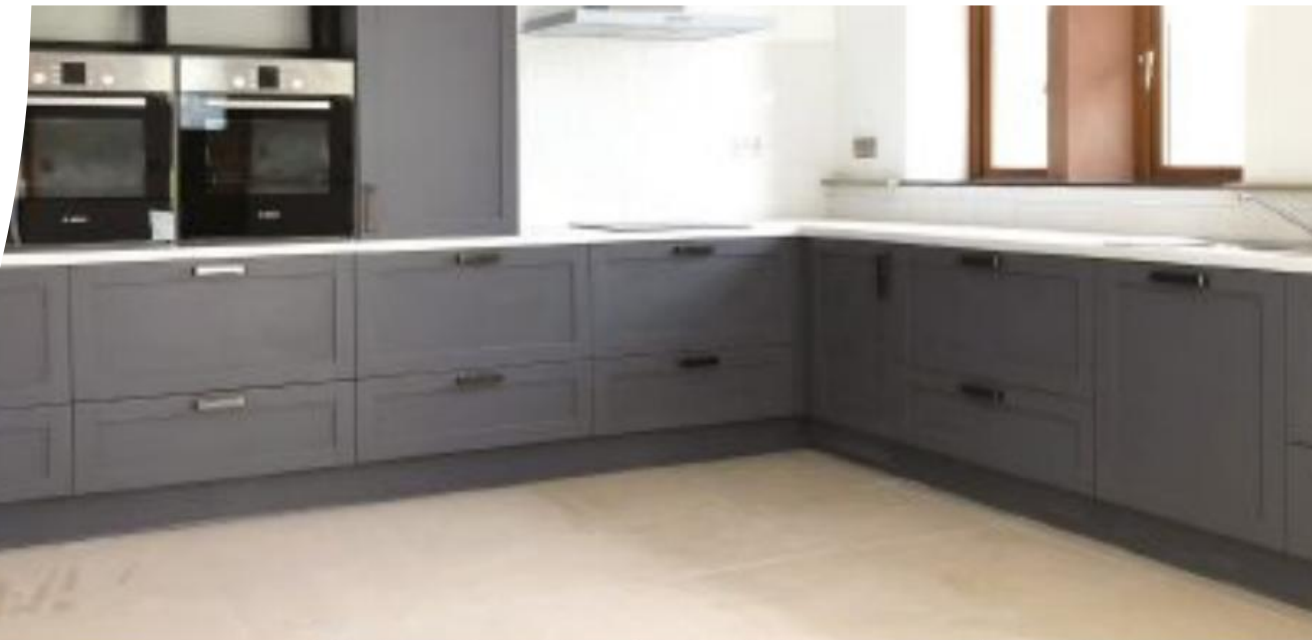
The Result

Hose down, dry, decorate
and move back home

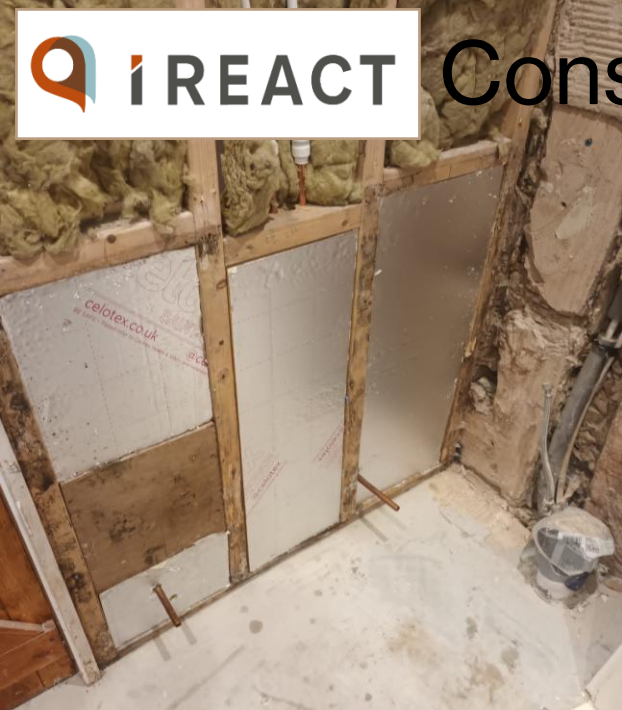
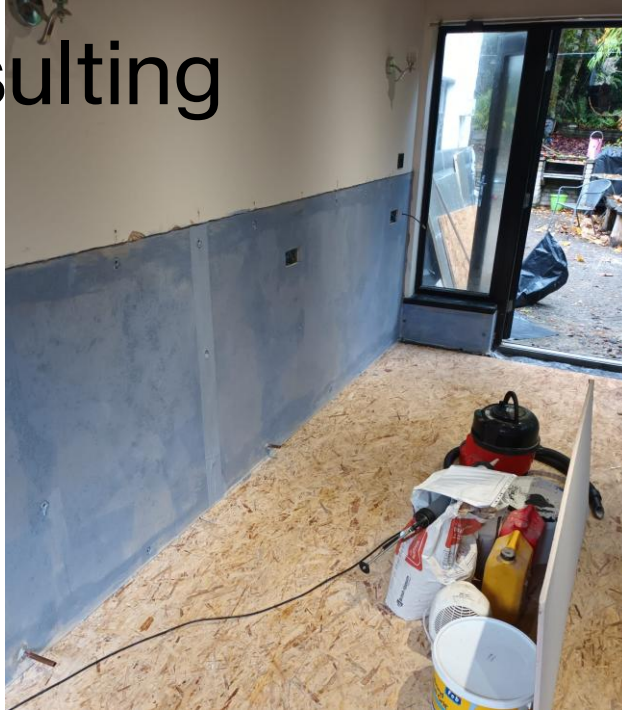
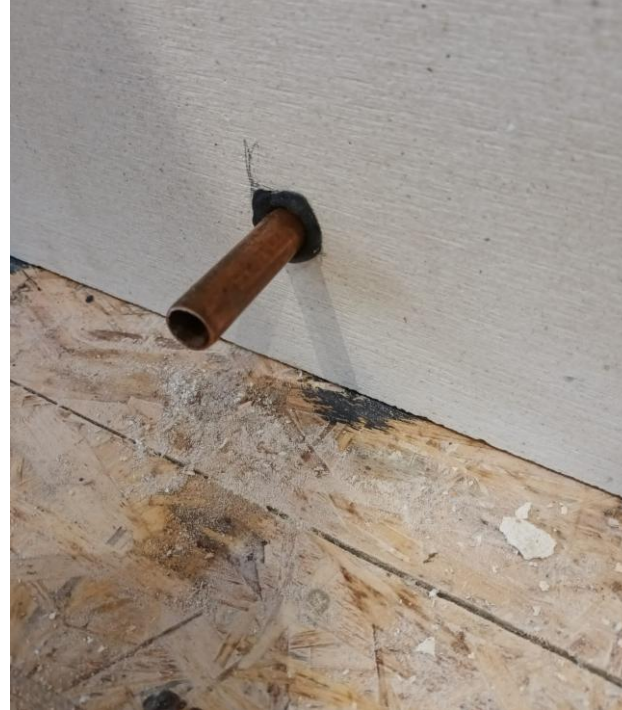
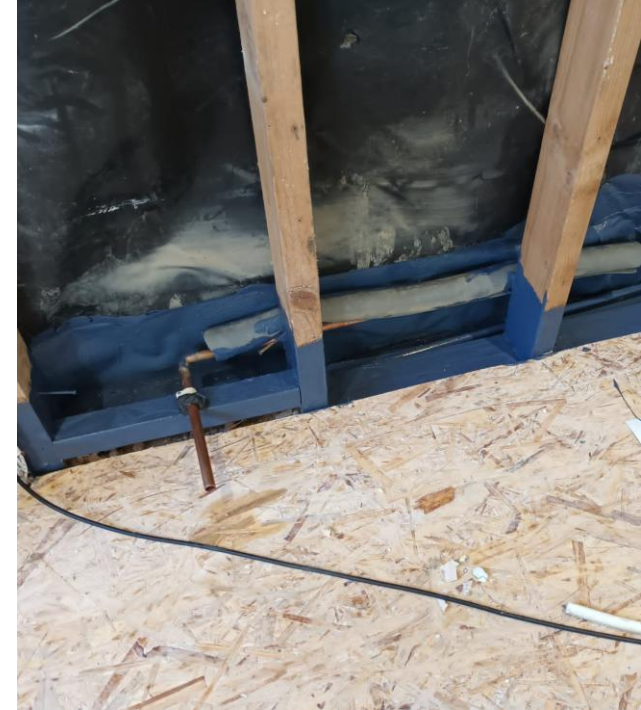
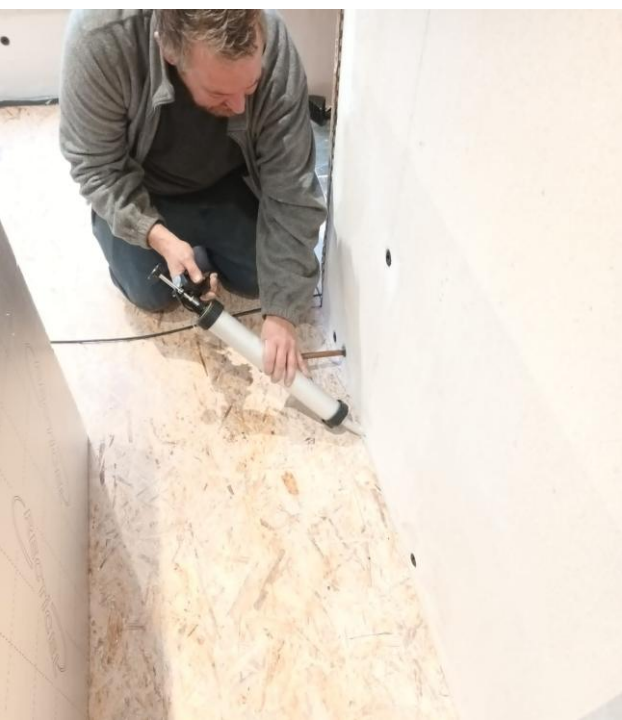
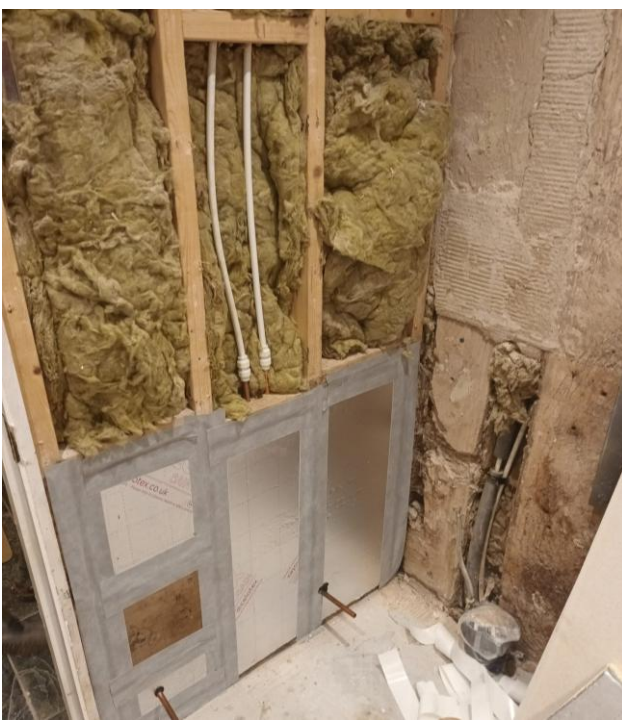
The Conservatory...

... was never going to keep water out so we let it in

- ✓ Closed cell insulation, with all gaps taped & sealed
- ✓ Painted slurry to wall floor junction with fillet in join
- ✓ Dragonboard to finish, sealed to floorboards
- ✓ Note special (yellow/black) fittings to ensure watertight fixing to wooden studs

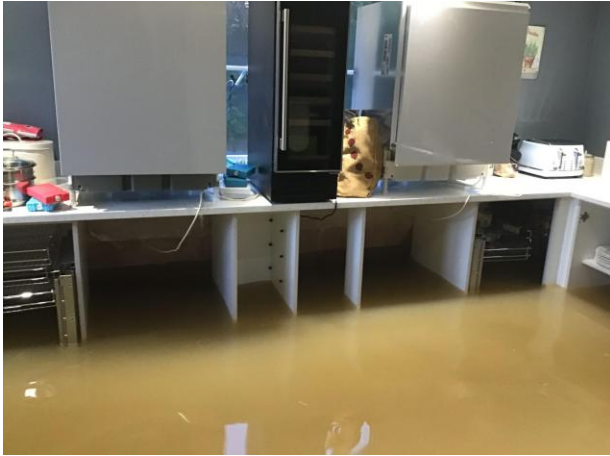
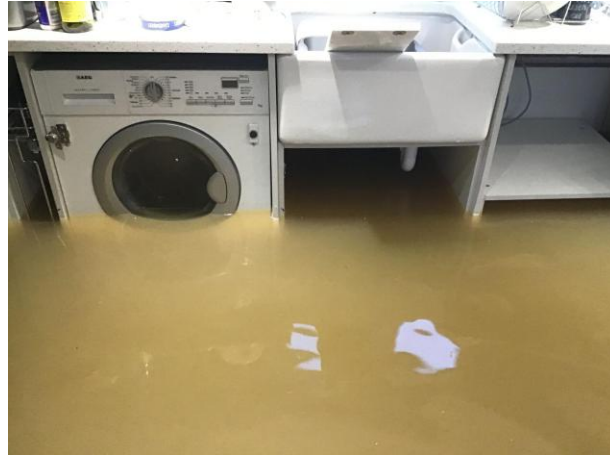
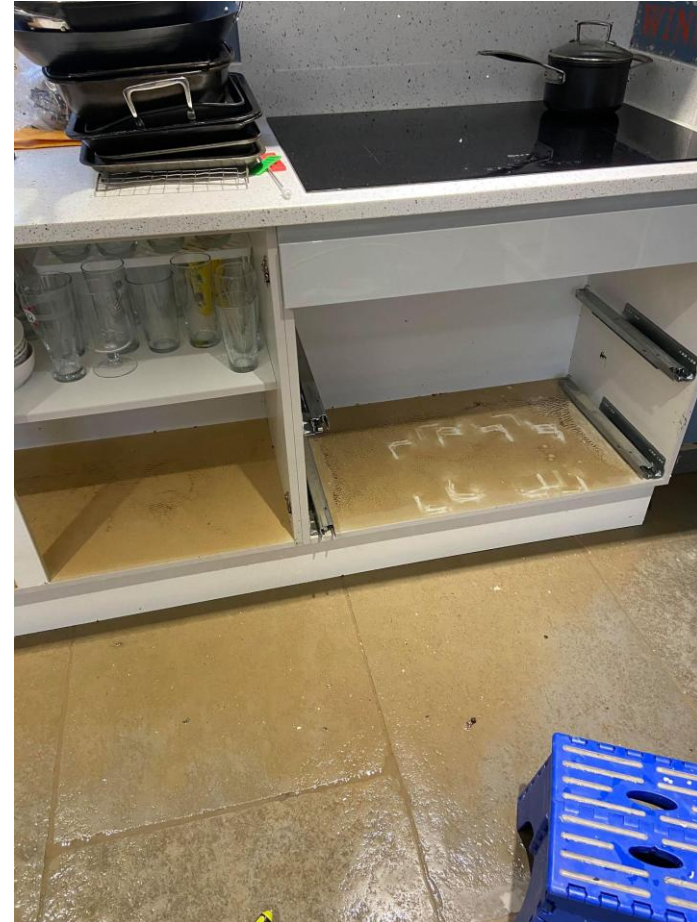
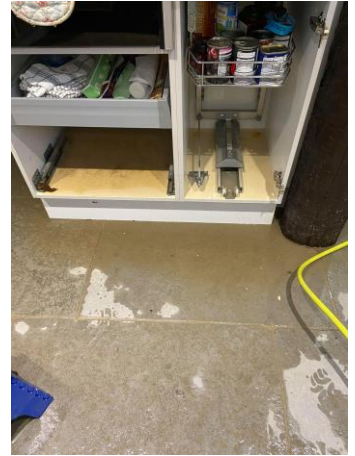
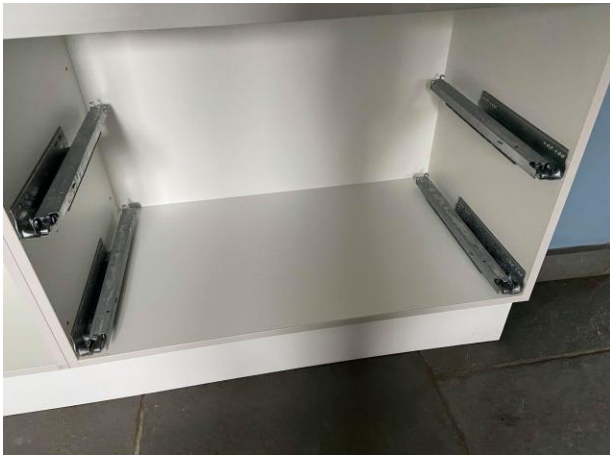
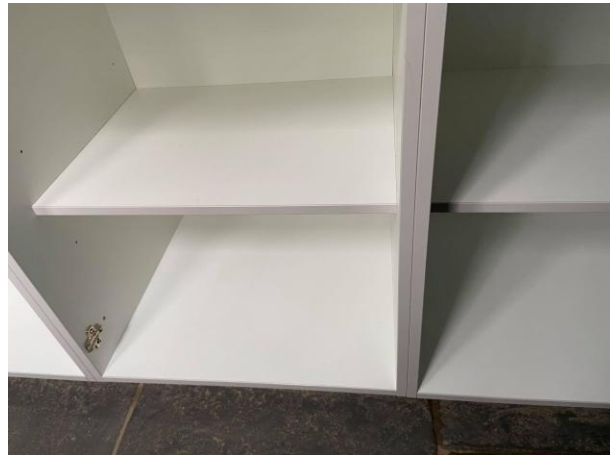
Attention to detail

- Internal stud walls with closed cell insulation at bottom, wool at top
- Heating pipes sealed back & front as they pass through boarding
 - Floor inside stud wall treated with slurry
- Timbers treated with slurry. Could include Boron rods too

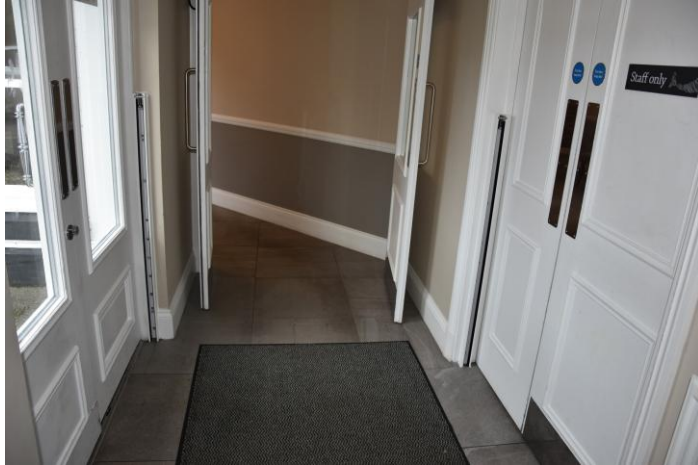
The solution

- FOCUS on the core infrastructure
- What gets the hotel back into business the fastest?
- The kitchen, bar and dining room – the heart of the hotel
- Internal barriers in corridors to protect the heart of the hotel
- External flood barriers to doors and windows due to height of flooding
- Creation of **FERP** (Flood Emergency Response Plan) for manually deployed barriers with biannual dry runs
- Kitchen replaced with stainless steel furniture
- Kitchen ring fenced with internal barriers to doorways at 1m high
- Dining room wood walls treated with **nanoshell** with multiple pumps under raised floor

Solution cost **£230,000**

- Internal flood barriers to heart of hotel
- External window barrier
- Replacement floodproof window arrays

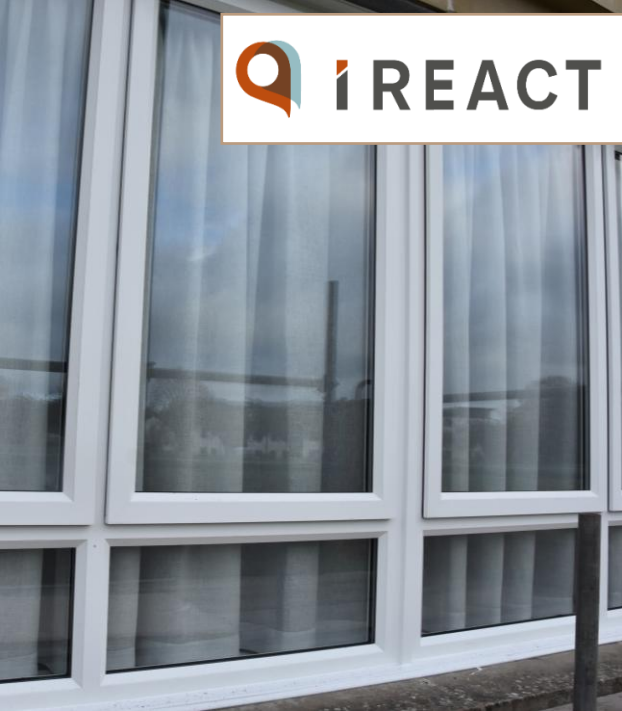
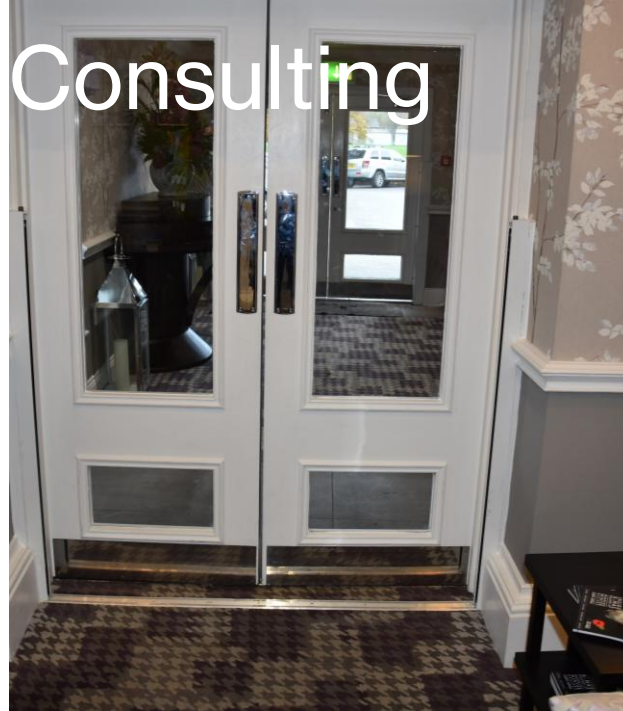
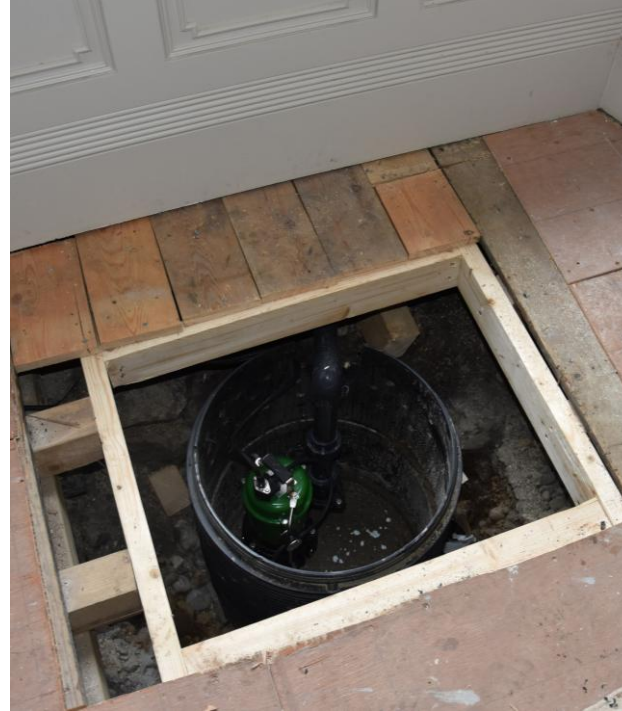
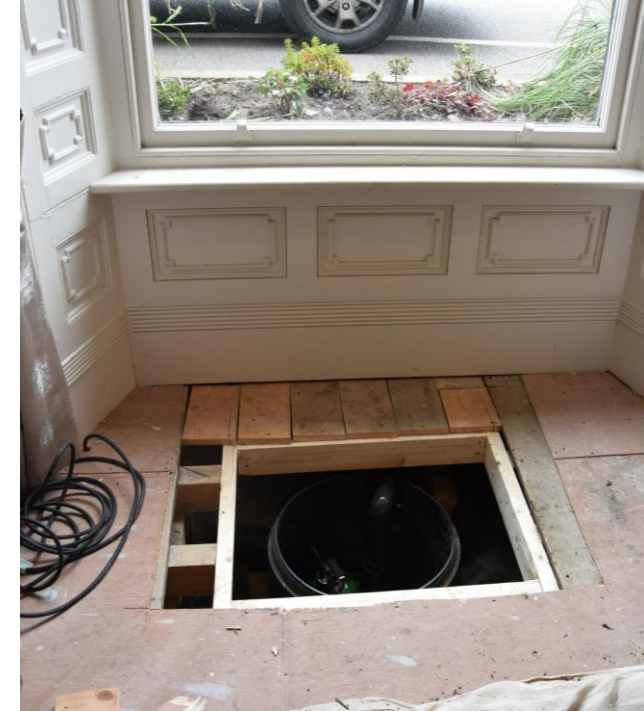
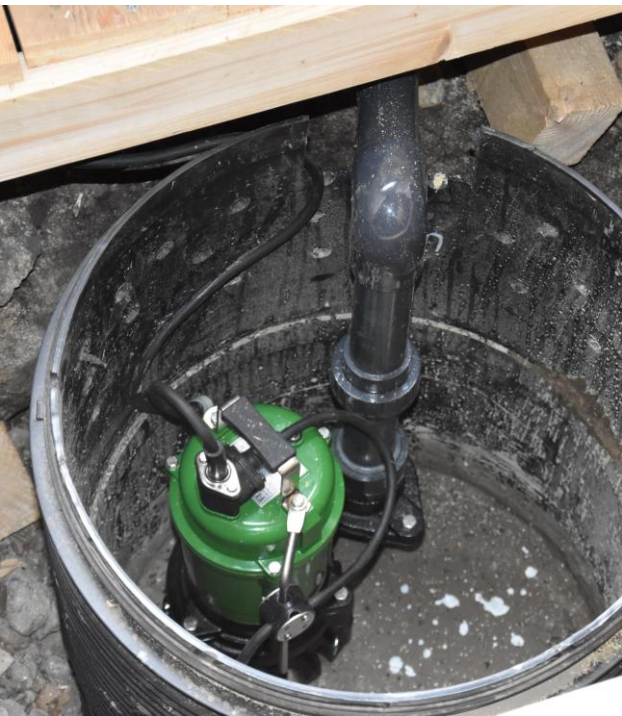
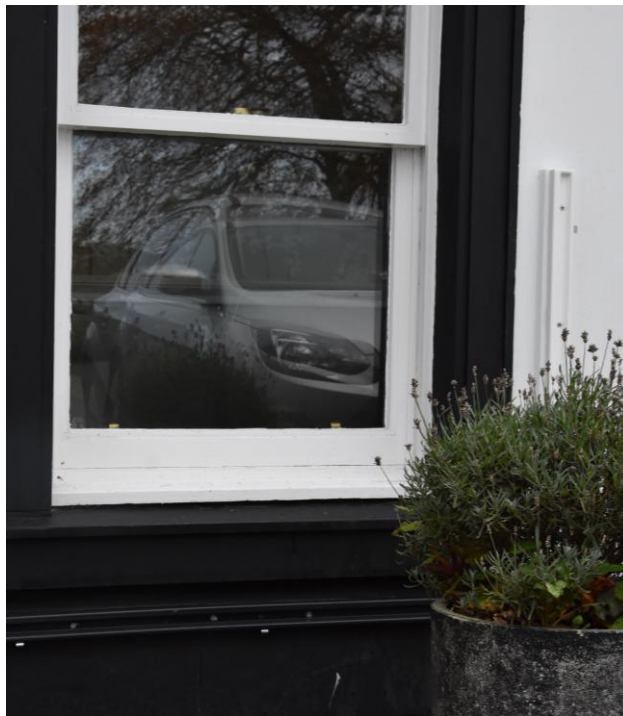
A LOOK AT SOME OF THE SOLUTIONS
